The importance of the historical field tents at Otterburn Mill, Northumberland

Dr Graham Cooper, Landscape Researcher

24 November 2022

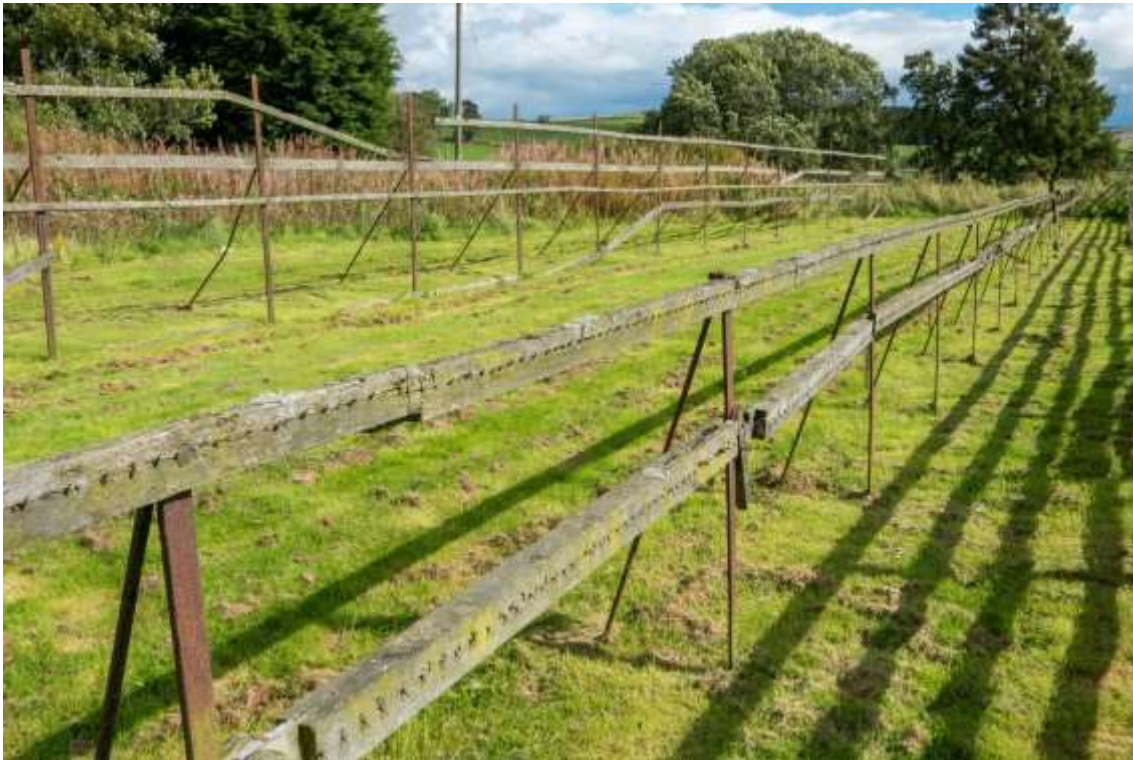
Figure 1. Tenters at Otterburn Mill showing the two seams for different cloth widths.

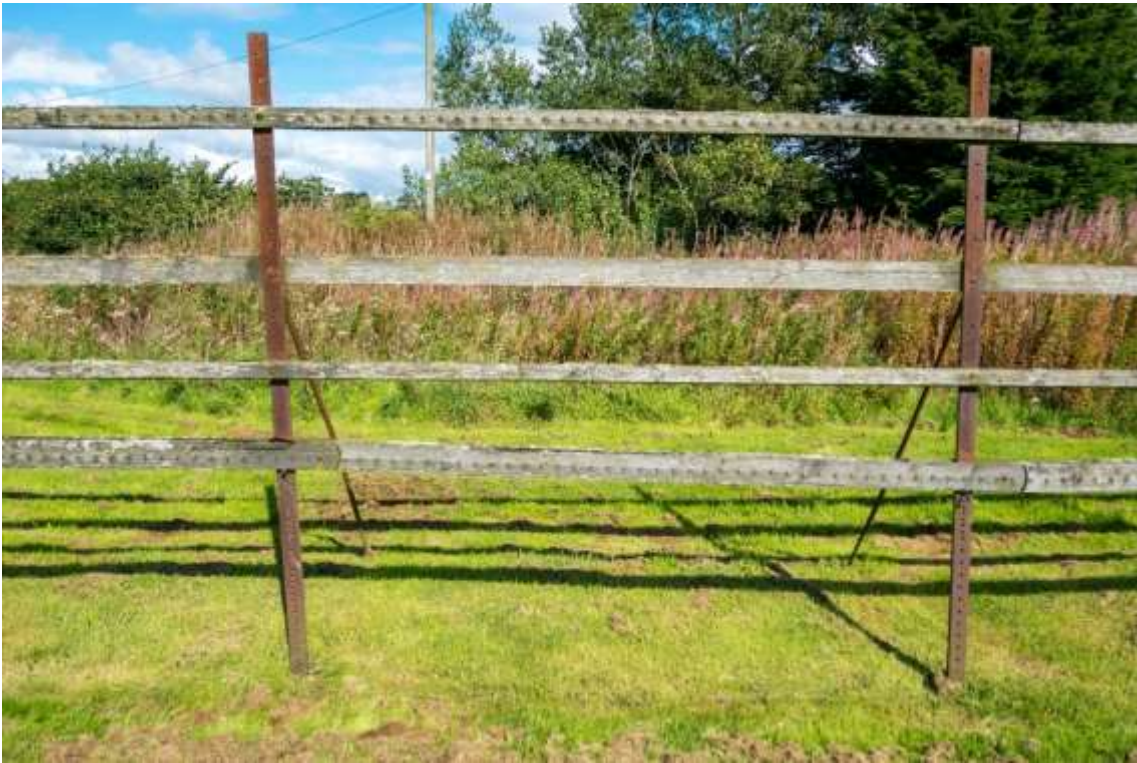
Figure 2. Note the holes in the iron posts to adjust cloth widths. The original pins and retaining chains are missing .

19th century. They are not marked with a maker's name. Tenter beams containing the tenterhooks were usually oak. The remaining beams still retain most of the tenterhooks. The lower bar is adjustable for cloth width, but only a small number of the original chains and pins for the fixing holes remain.

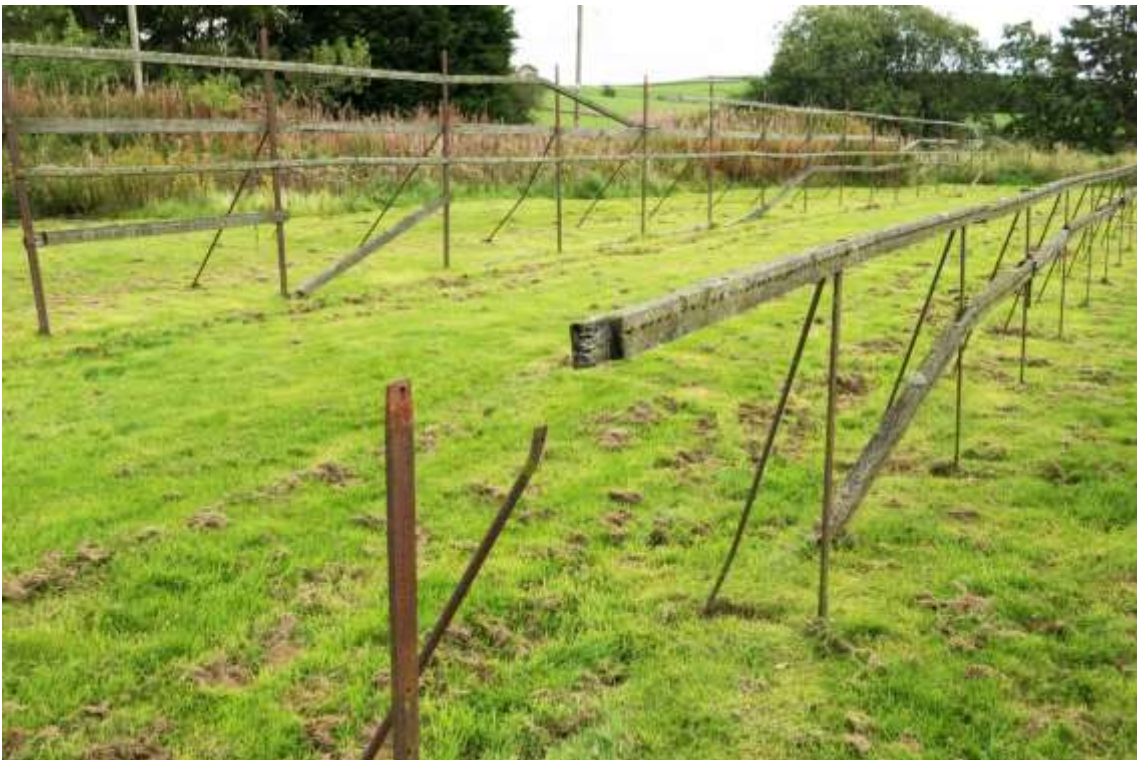
Figure 3. Damage and missing sections to parts of the two seams in 2017. There has been further damage due to recent flooding.

Plainly, the tenters have been weathered and slowly deteriorated. Some of the lower beams have fallen completely or detached at one end. But in general, given their age, in 2017 they were in reasonable condition. The decline has accelerated recently.

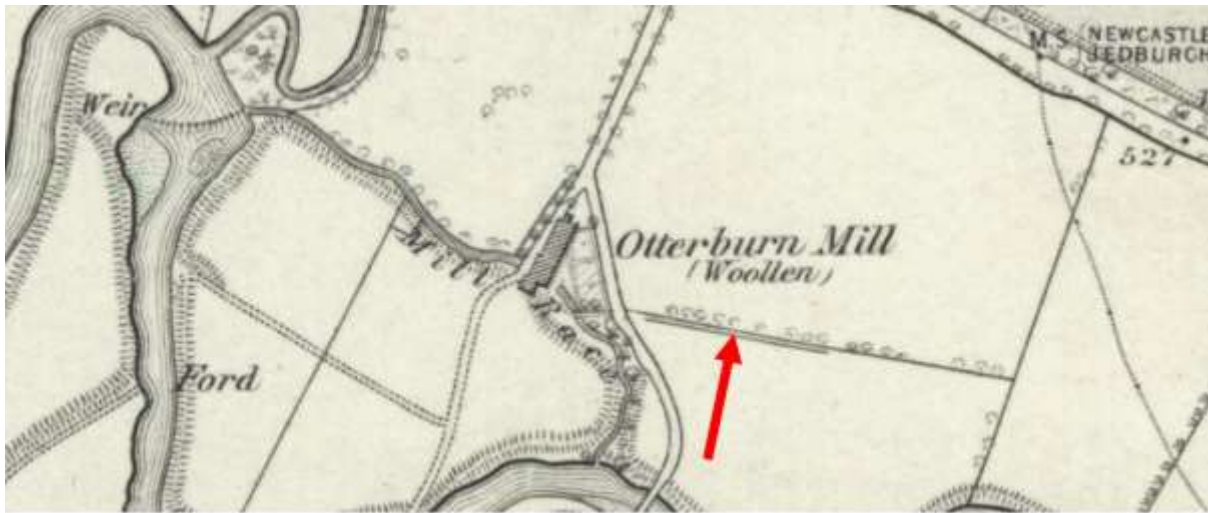
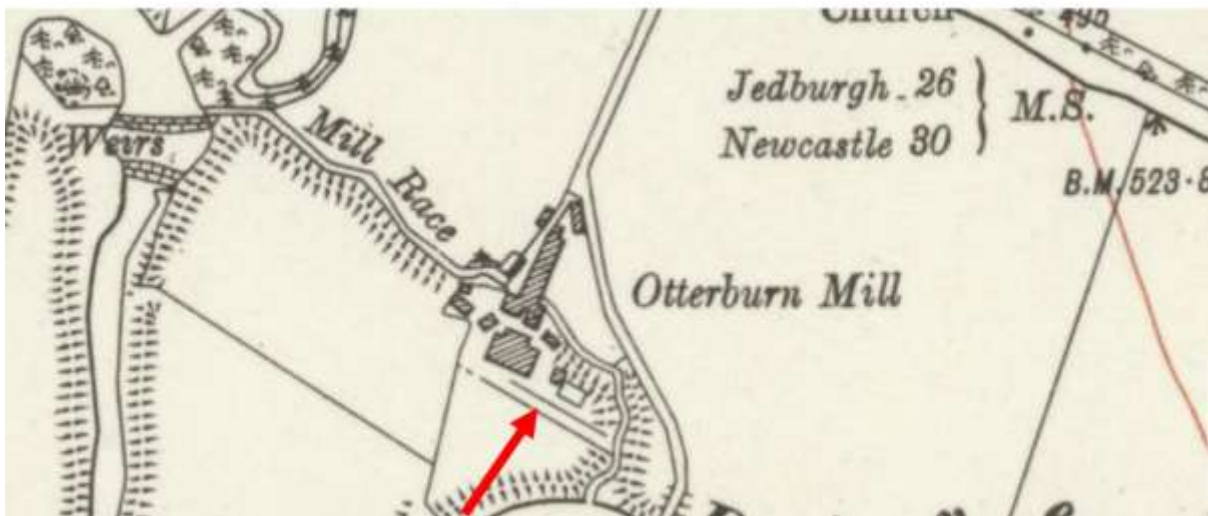
Figure 4. Upper: tenter (arrow) alongside a field boundary, 1863. Lower: tenters in 1921 (arrow) south of an extension to the original mill, at or very close to the site of the tenters remaining today. Maps are 6-inches to 1 mile OS. Reproduced with the permission of the [National Library of Scotland](https://www.nls.uk/). Used under the Creative Commons Attribution (CC-BY) licence.

The earliest representation of tenters at the mill is on the 6 inches to 1 mile 'First Edition' OS map (1:10560), surveyed in 1863. Depicted on this map, in the field across the road from the mill, is a field boundary (now removed, but two trees remain to show the line). Parallel to the boundary and very close to it immediately south, is a short single line (Figure 4, upper). This is a field tenter; (it was common for single tenters in fields to be erected close to boundaries). No tenters are shown on the mill site. Neither the 1896 revision of the 6 inches map nor the 1896 25 inches to 1 mile (1:2500) show tenters.

On a 6 inches map surveyed in 1921, the 1863 field boundary and tenter across the road are not depicted, but on the mill site, south of extensions to the main building and detached smaller structures, there is certainly one, and probably two tenters evident⁷. These tenters appear to be at the same location as the tenters remaining today (Figure 4, lower) and may indeed be the same structures, implying they were erected before 1921.

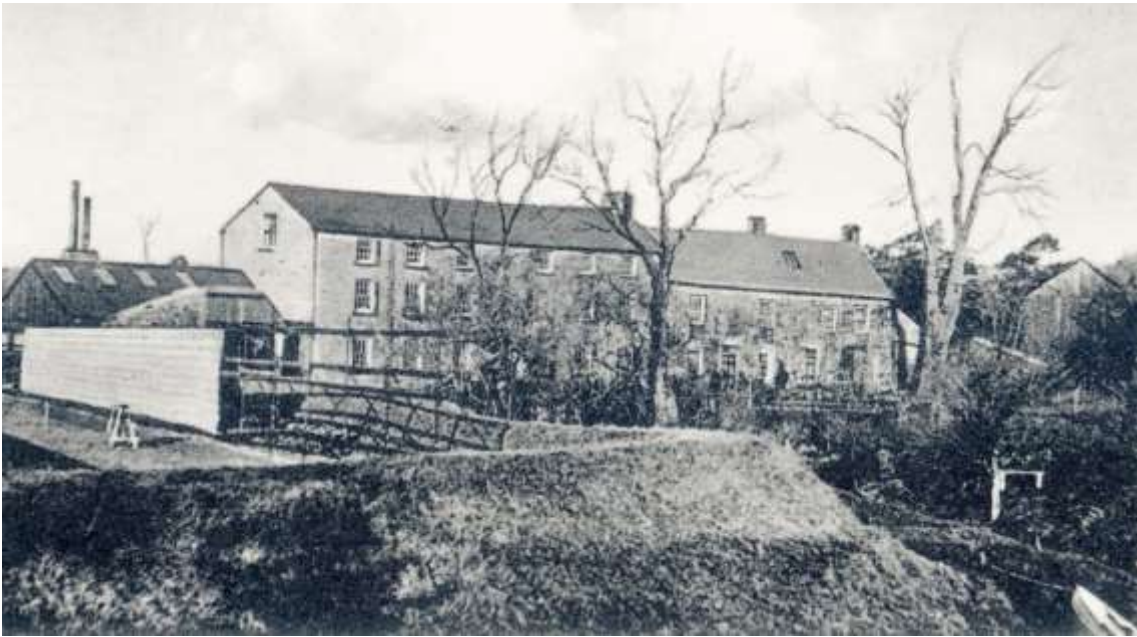
Figure 5. Pre-1918 photograph of tents adjacent to flood defences. This tenter site may be that shown in Figure 6.

Figure 5 is taken from a postcard produced before 1918.⁸ There are tenters adjacent to the flood bank, with the mill race just the other side of the defence. These tenters are no longer present.

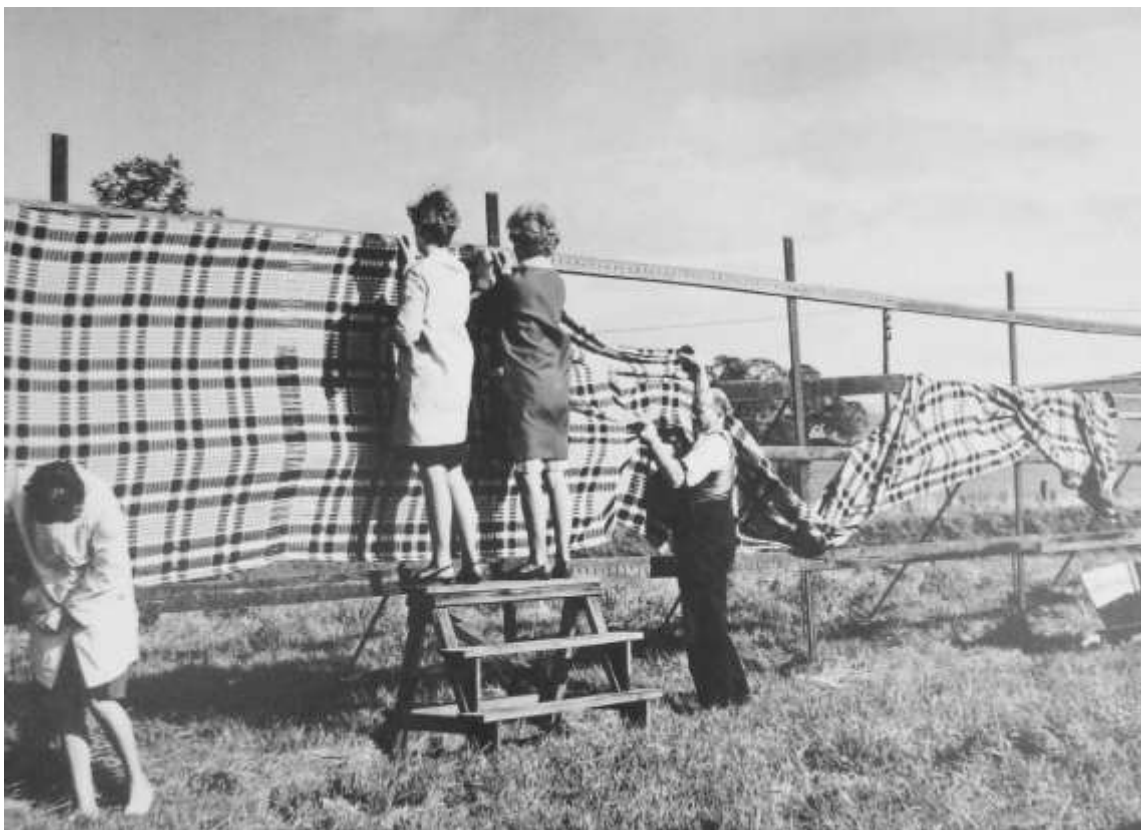
Figure 6. Cloth being mounted on tents at Otterburn. The date is unknown, probably post-WW2.

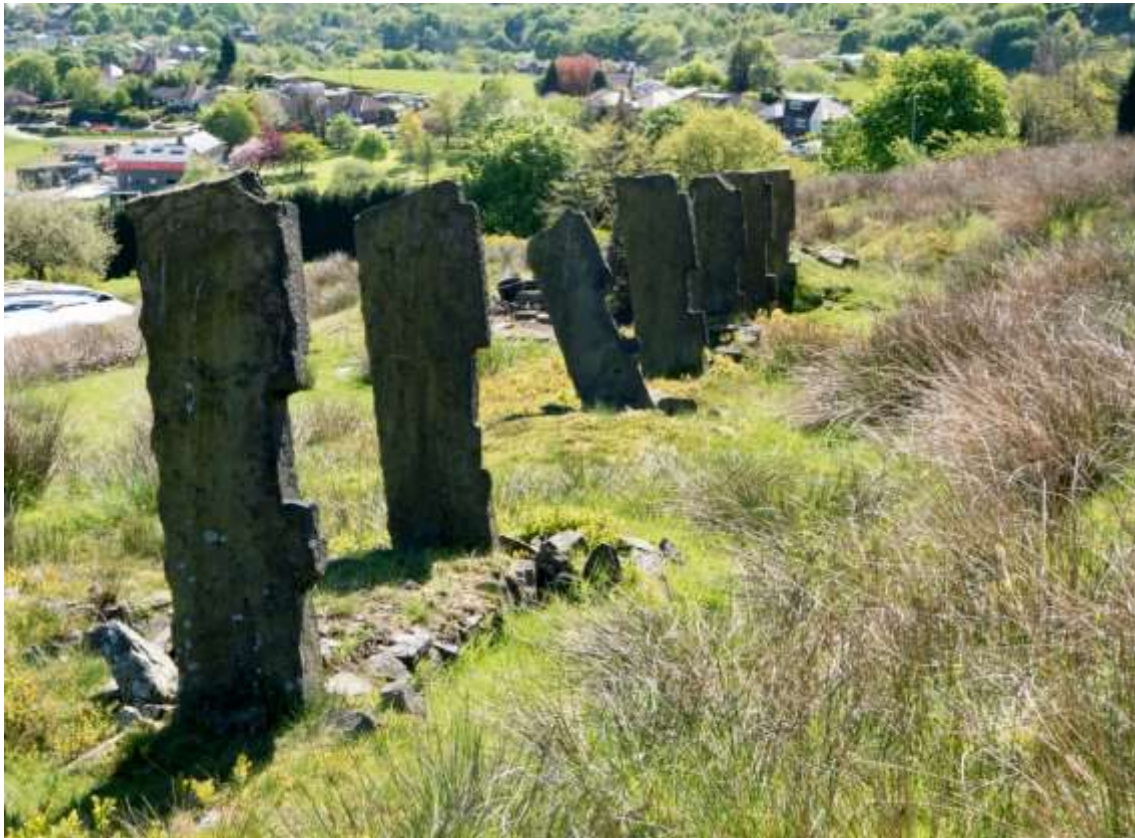
Figure 7. Isolated and remarkable stone tenter posts, Wall Hill, Dobcross, Greater Manchester. Probably erected by flannel manufacturers Robert Greaves, Joseph and Robert Cooper about 1840.

Remarkably, there were no structural remains of wooden/iron tenters in this important, very active woollen cloth-making area, that originally contained thousands of tenter seams. A few of the rare stone support posts were noted, largely in the Saddleworth/Marsden areas. An outstanding set is at Wall Hill near Dobcross, erected about 1840 (Figure 7). Figure 8 shows another set of stone tenter posts in Marsden alongside a large mill. Stone posts are rare and were very uncommon historically, confined largely to this small area around the two towns. Conventional iron/wooden posts would have found other uses elsewhere when tenters were disposed of, but stone posts had few alternative uses, except perhaps in walling. Many were simply abandoned and remain *in situ*.

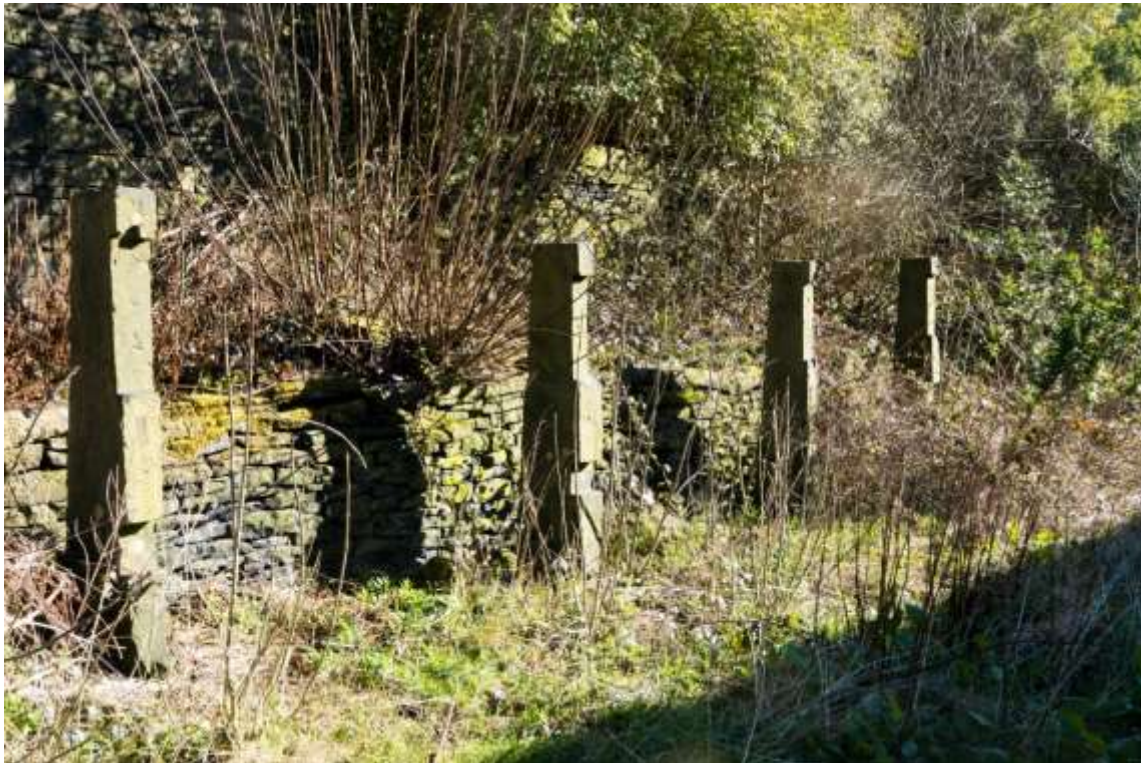
Figure 8. Stone tenter posts at Marsden, West Yorkshire, probably early 19th century. They are sited in an urban setting outside a large mill. Note the slots for adjustable tenterhook beams.

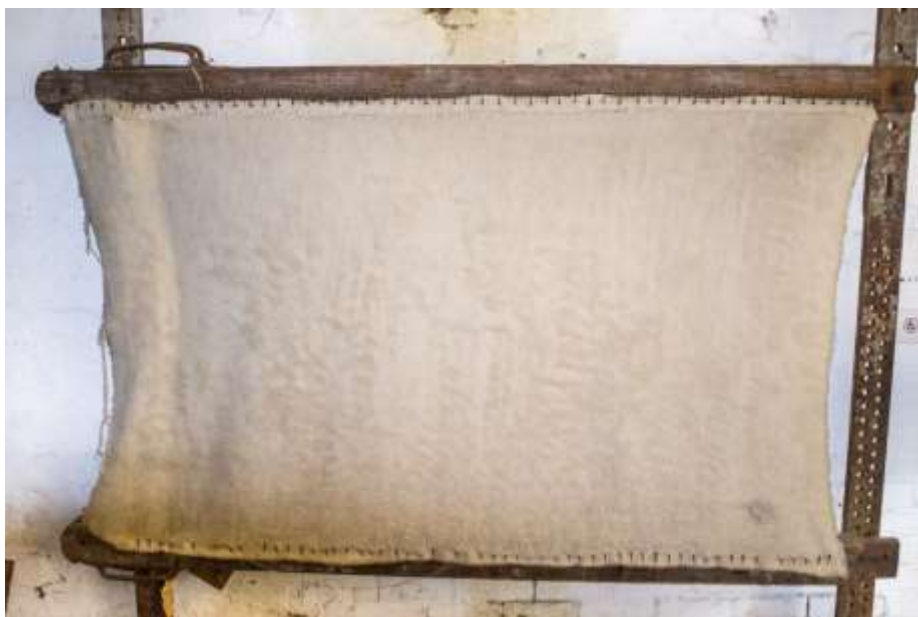
Figure 9. A section of an indoor tenter at Helmshore Mills Textile Museum, Lancashire, owned by Lancashire County Council. The mills also had field tenters, now gone, sited on an adjacent hill.

The Helmshore Mills Textile Museum in Lancashire has retained a short section of their *indoor* tenters with fulled cloth attached (Figure 9). A few museums do have displays showing tenterhooks with a short piece of cloth attached, but they are not in any structural or industrial context.
